EASTMAN PERFORMANCE FILMS, LLC

AIRBLAST LOADING TEST REPORT

ASTM F1642/GSA TS01 TESTING ON *DR15 SR PS9* SAFETY AND SECURITY PERFORMANCE FILM
INSTALLED ON A FIXED WINDOW SYSTEM
(DUAL PANE, TEMPERED, SILICONE GLAZING ATTACHMENT)

J3983.06-119-12 R0

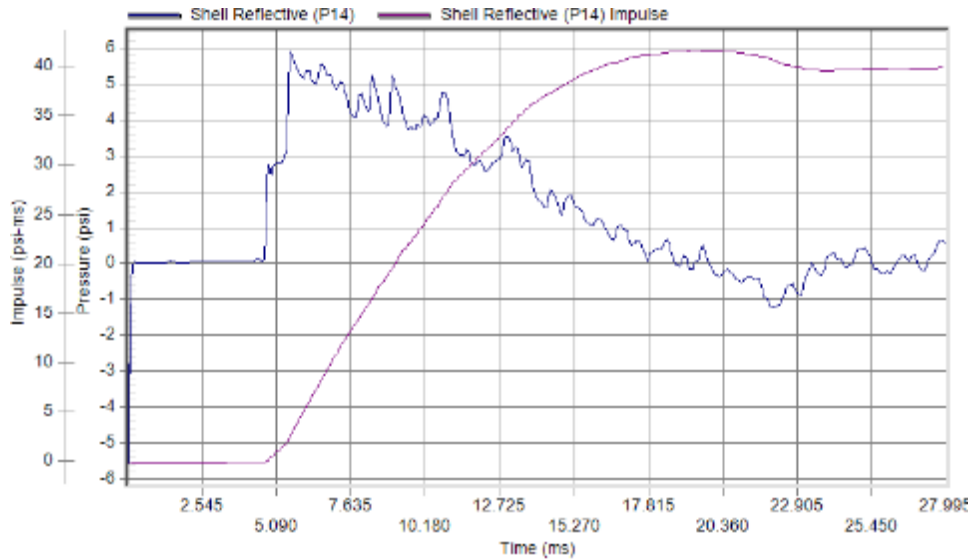
Test Specimen #3 - Pressure Time Plots

Peak Pressure: 5.95 psi at 5.59 ms
Duration: 13.13 ms

Peak Pressure: 6.43 psi at 6.38 ms
Duration: 12.03 ms

Peak Pressure: 6.22 psi at 7.47 ms
Duration: 10.66 ms

Peak Pressure: 0.20 psi at 25.67 ms
Duration: 1.56 ms

DESCRIPTION	RESULTS
Ambient Temperature	80°F
Glazing Temperature	80°F
ASTM Hazard Rating	No Break
GSA Performance Condition	1
PEAK POSITIVE PRESSURE	
Top Pressure	6.22 psi
Right Pressure	6.43 psi
Shell Pressure	5.95 psi
Average Pressure	6.20 psi
Witness Chamber Pressure	0.20 psi
PEAK POSITIVE PHASE DURATION	
Top Duration	10.66 msec
Right Duration	12.03 msec
Shell Duration	13.13 msec
Average Duration	11.94 msec
PEAK POSITIVE PHASE IMPULSE	
Top Impulse	42 psi*msec
Right Impulse	42 psi*msec
Shell Impulse	42 psi*msec
Average Impulse	42 psi*msec
GLAZING RESPONSE	
Exterior Lite	Unbroken
Interior Lite	Unbroken
Glazing Pullout	None
Film Tearing	None
WITNESS CHAMBER RESULTS	
No debris was observed.

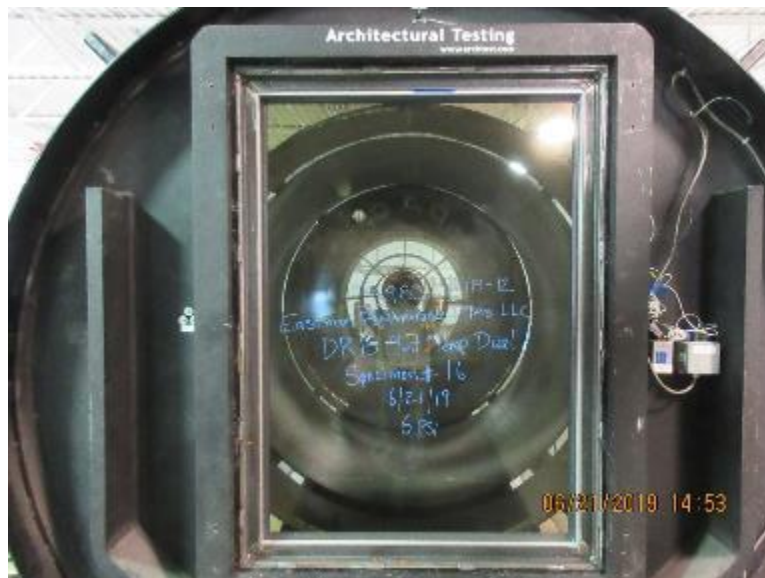
Photo No. 1
Pre-test Specimen #1, Interior

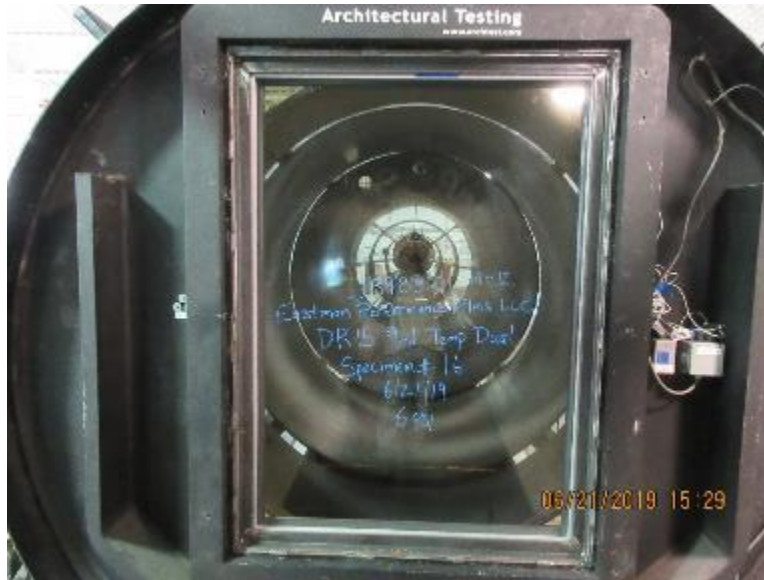
Photo No. 2
Post-test Specimen #1, Interior

DESCRIPTION	RESULTS
Ambient Temperature	81°F
Glazing Temperature	81°F
ASTM Hazard Rating	No Break
GSA Performance Condition	1
PEAK POSITIVE PRESSURE	
Top Pressure	6.31 psi
Right Pressure	6.93 psi
Shell Pressure	5.91 psi
Average Pressure	6.38 psi
Witness Chamber Pressure	0.14 psi
PEAK POSITIVE PHASE DURATION	
Top Duration	13.00 msec
Right Duration	8.82 msec
Shell Duration	13.44 msec
Average Duration	11.76 msec
PEAK POSITIVE PHASE IMPULSE	
Top Impulse	41 psi*msec
Right Impulse	41 psi*msec
Shell Impulse	41 psi*msec
Average Impulse	41 psi*msec
GLAZING RESPONSE	
Exterior Lite	Unbroken
Interior Lite	Unbroken
Glazing Pullout	None
Film Tearing	None
WITNESS CHAMBER RESULTS	
No debris was observed.

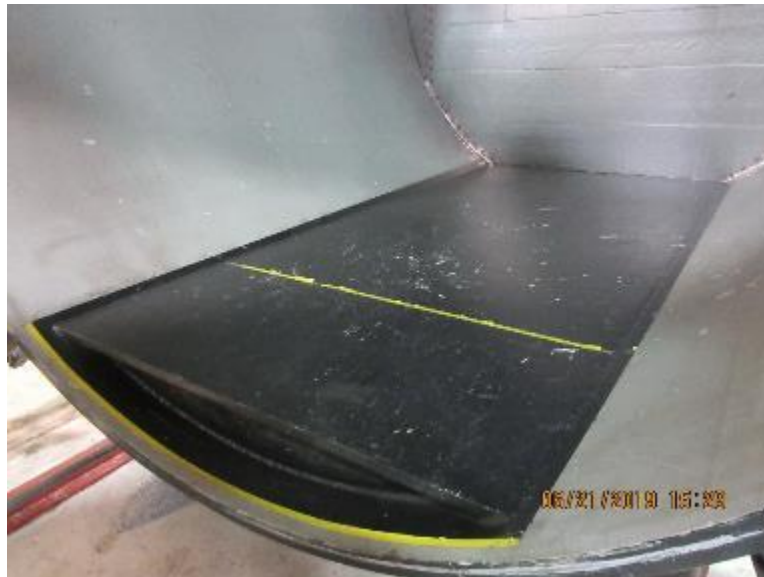
Photo No. 3
Post-test Specimen #1, Witness Chamber

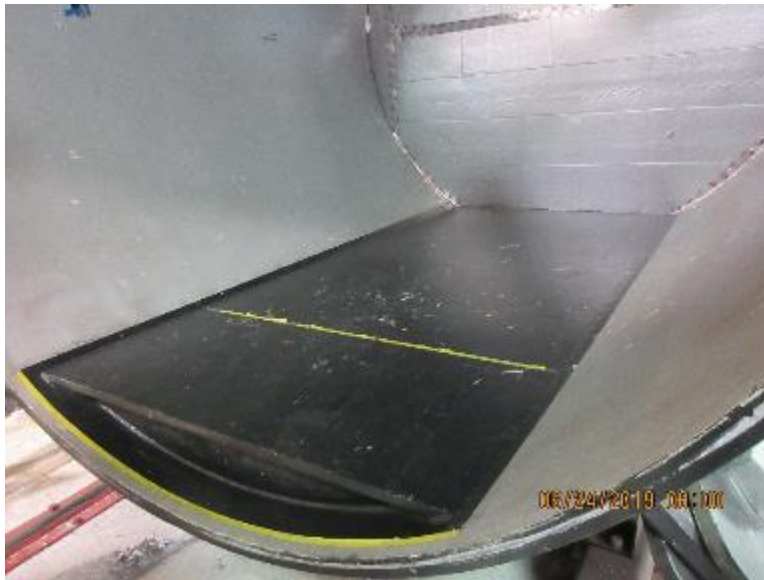
Photo No. 6
Post-test Specimen #2, Witness Chamber

DESCRIPTION	RESULTS
Ambient Temperature	81°F
Glazing Temperature	82°F
ASTM Hazard Rating	No Break
GSA Performance Condition	1
PEAK POSITIVE PRESSURE	
Top Pressure	6.14 psi
Right Pressure	6.27 psi
Shell Pressure	6.00 psi
Average Pressure	6.13 psi
Witness Chamber Pressure	0.19 psi
PEAK POSITIVE PHASE DURATION	
Top Duration	12.77 msec
Right Duration	11.33 msec
Shell Duration	0.14 msec
Average Duration	8.08 msec
PEAK POSITIVE PHASE IMPULSE	
Top Impulse	42 psi*msec
Right Impulse	42 psi*msec
Shell Impulse	42 psi*msec
Average Impulse	42 psi*msec
GLAZING RESPONSE	
Exterior Lite	Unbroken
Interior Lite	Unbroken
Glazing Pullout	None
Film Tearing	None
WITNESS CHAMBER RESULTS	
No debris was observed.

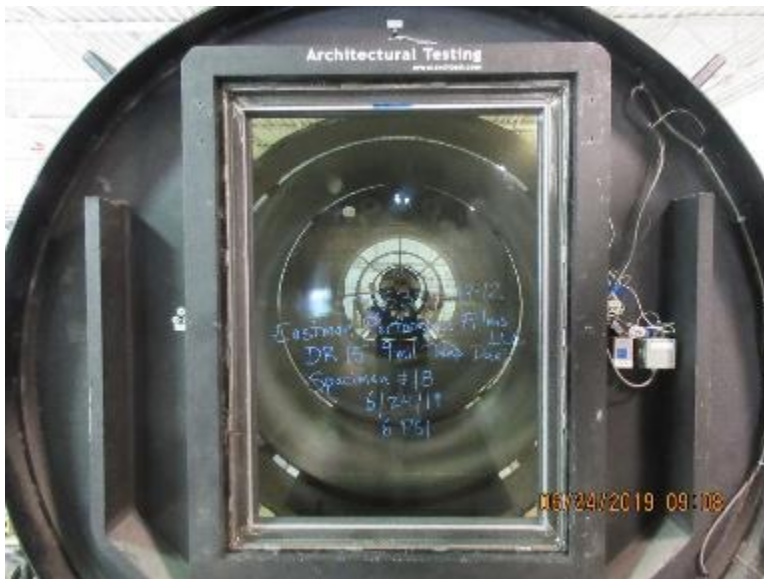
Photo No. 7
Pre-test Specimen #3, Interior

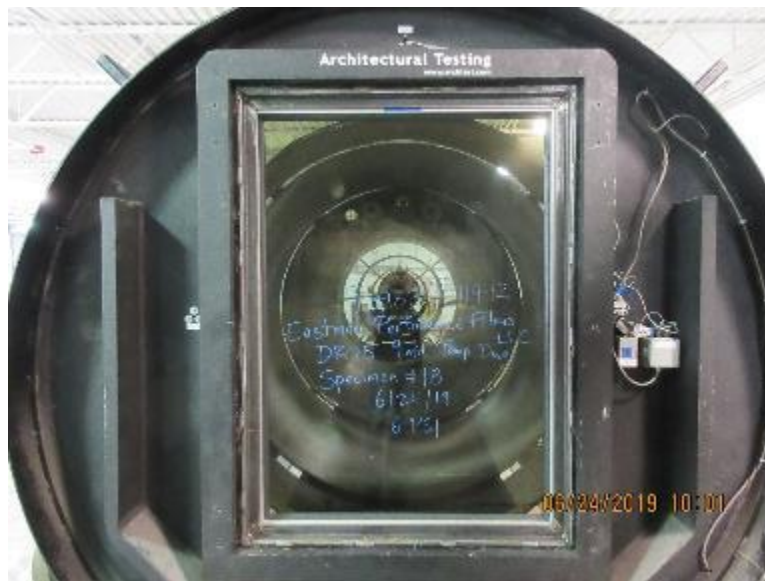
Photo No. 8
Post-test Specimen #3, Interior

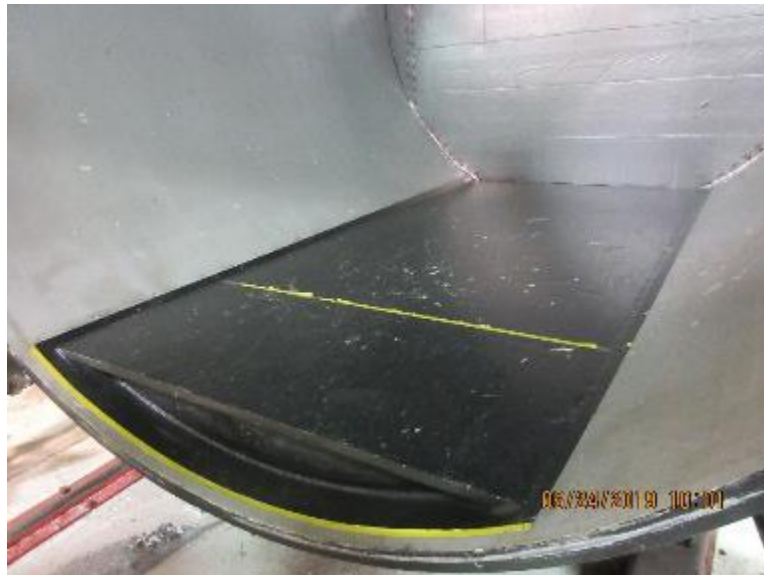
Photo No. 9
Post-test Specimen #3, Witness Chamber
